INJURY ANALYSIS OF LAMINATED AND TEMPERED SIDE GLAZING

Stephen A. Batzer
Chandra K. Thorbole
G. Grant Herndon

David Beltran
The Engineering Institute
United States
Paper Number 07-0101

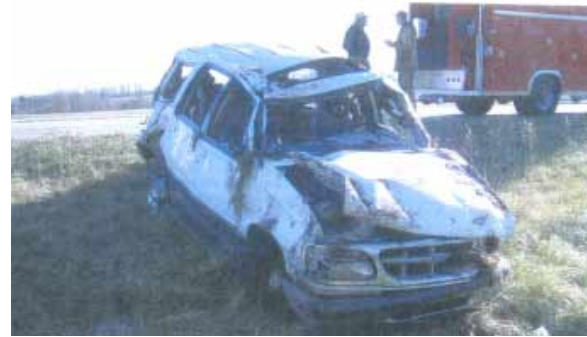
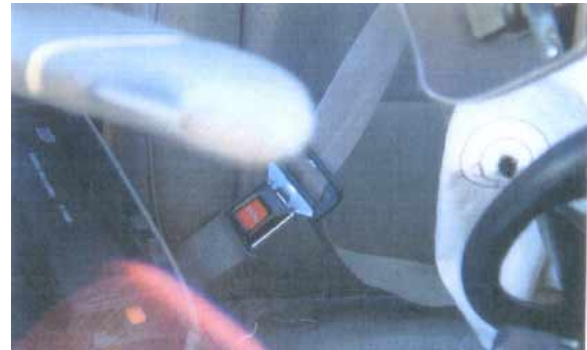
Figure 4: Sport utility vehicle rollover with sunroof ejection, probable 3 complete rolls [29].

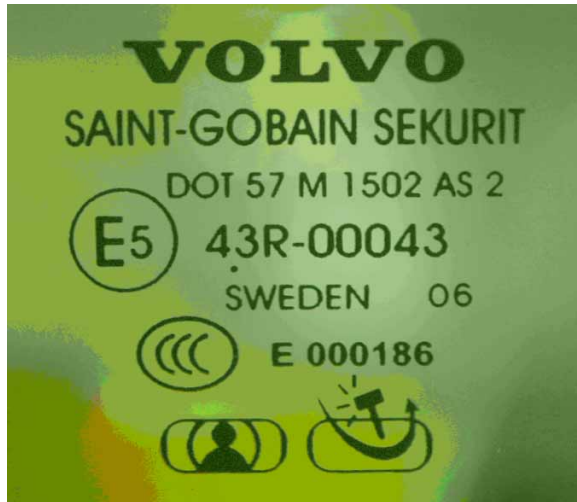
Figure 5: Laminated side glazing pictograms signifying “occupant containment” (left) and “exterior impact resistance” (right).

effective occupant containment, even for those 6 tests with unbelted first row anthropomorphic test dummies (ATDs). A set of pictograms currently applied to many St. Gobain laminated glass side windows is shown in Figure 5, indicating its energy absorption capability, showing occupant retention at lower left, and intrusion resistance at lower right.

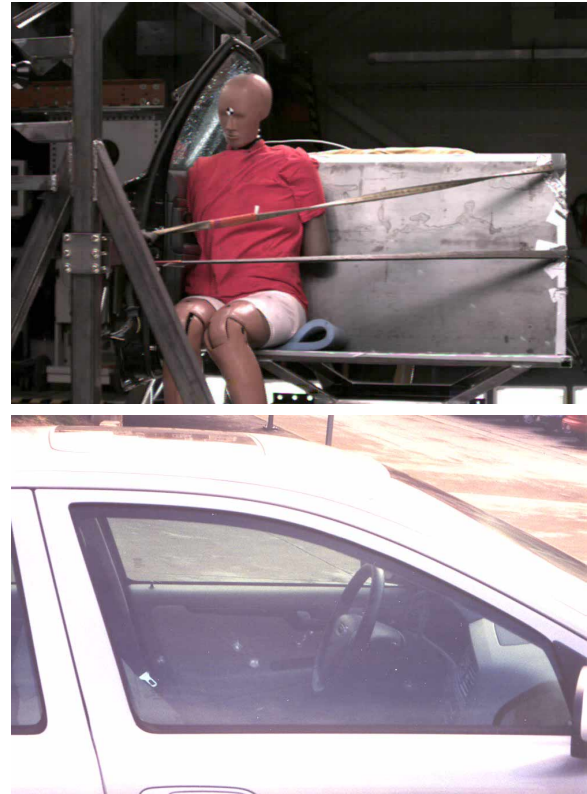
Figure 6: Volvo S80 glass impact performance - containment (top); security (bottom).

The proof of the efficacy of laminated glass is shown in the two photographs of Figure 6. The top photo shows an ATD impact into a Volvo S80 right rear door at an initial inclination angle of approximately 17° at a nominal 16 kph (10 mph). The second photo at bottom shows a laminated S80 front door with two surface chips indicating a foiled entry attempt.

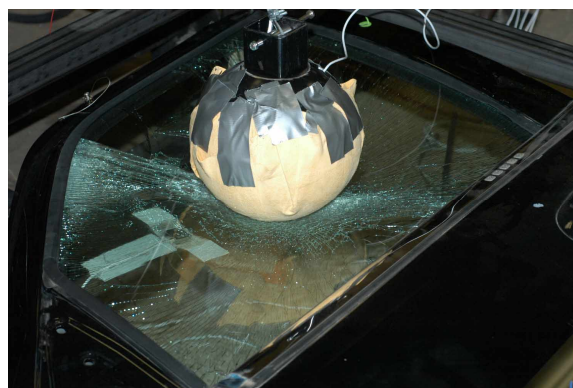
Figure 13: Blunt impactor testing of EPG style laminated side glazing.

In multiple-roll rollovers, the possibility exists for multiple impacts against laminated occupant-retention glazing. Batzer, et al. [7], found that the laceration potential did not substantially increase in multiple impacts against EPG style laminated side glass with multiple impacts without through-glass penetration, Figure 13.

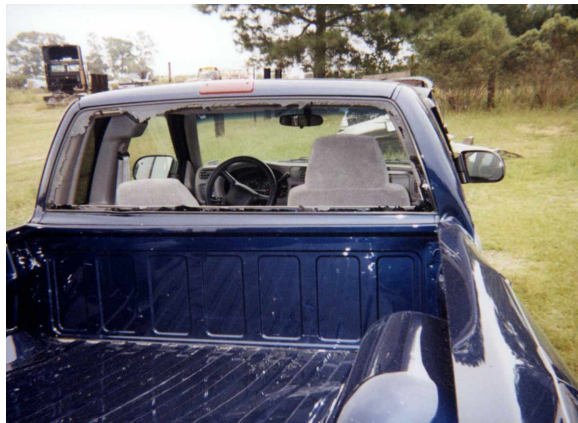
Figure 14 Fractured tempered back lite after rear impact. Driver penetrated window and was blinded in left eye.

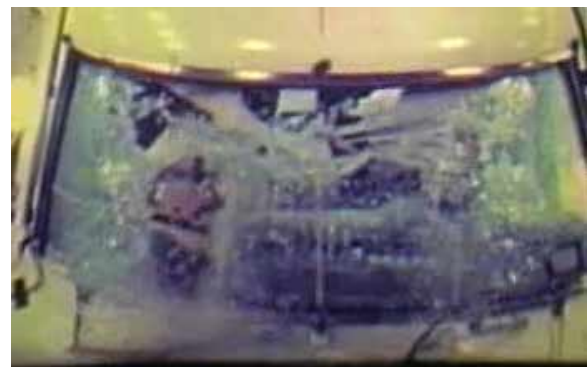
Figure 15: Passenger (right) side dummy impact against an HPR laminated windshield (top) and a tempered windshield (bottom) [23].

The impact against the HPR laminated windshield (top) shows typical performance. The glass fractures but largely remains adhered to the polymer interlayer. Spalled fragments are shown from the exterior glass ply against the dark background. The dummy's head does not show significant relative downward motion (scrub) against the inboard glass ply that would have presented an enhanced laceration hazard. The impact

against the tempered windshield produces progressive fracture of the glass, with maximized laceration. That is, the glass does not break and fly away in a single instant. It largely retained its planar shape and presented progressively formed edges against the dummy's face as the head moved forward and downward toward the dashboard.

The mechanism of increased laceration and ocular injuries produced by tempered over laminated HPR glazing is illustrated in the photographs given in the Figure 15. Note that these vehicles are not equipped with first row airbags. The vehicles were directed into a frontal impact with a fixed barrier at 12 o'clock. The unrestrained right-side dummies moved forward and impacted the dashboard with their knees and chests, and against the windshields with their heads.
